Modification volume en  
façade arrière

transformation  
d'une maison

ARCHITECTE

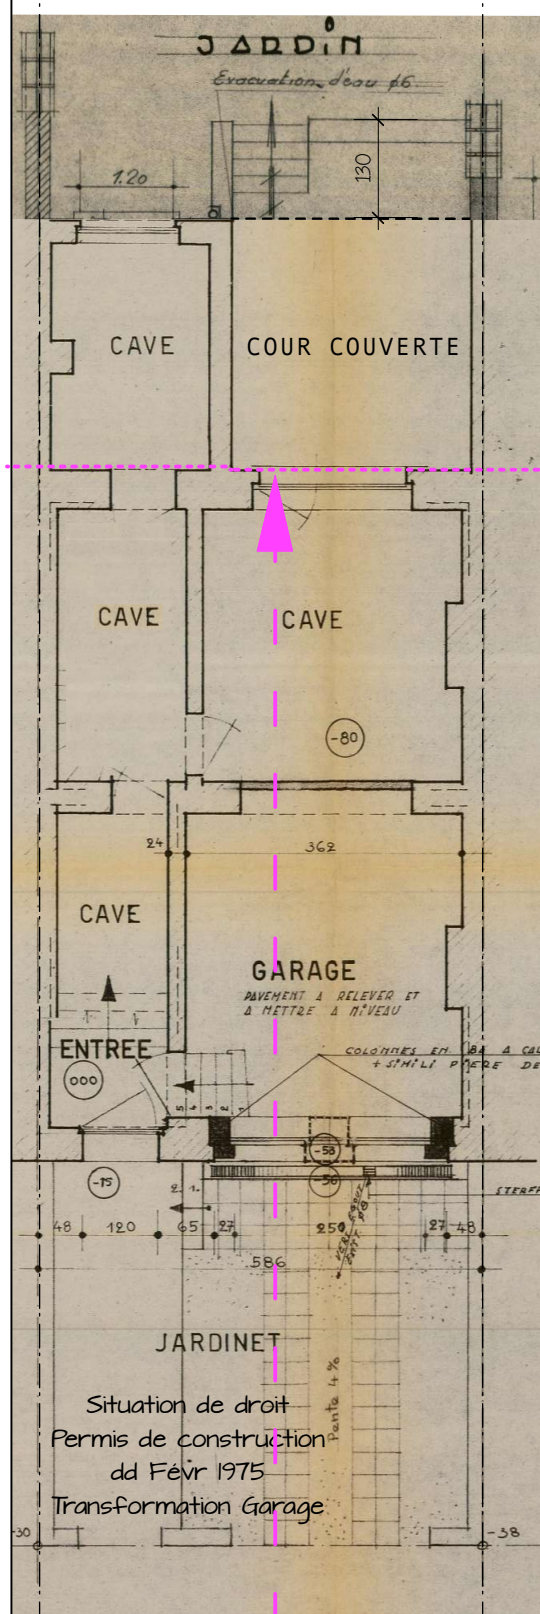
02<sup>bis</sup> / 31

The image displays two architectural floor plans side-by-side, comparing the 'Situation de fait' (current state) on the left with the 'Situation projetée' (projected state) on the right. The plans show a building layout with various rooms: Cave (cellar), Buanderie (laundry), Garage, and a Jardin (garden). Dimensions are provided for all rooms and setbacks. The 'Situation projetée' plan shows modifications, including a new 'Rangement jardinage' (garden storage) area and changes to the 'Cave' and 'Garage' spaces. A pink dashed line indicates the 'Alignement' (alignment). The bottom of the plans shows the 'klinkers béton 20/20' (concrete bricks 20/20) and 'éclairage public' (public lighting) details.

## Situation de droit

## Situation de fait

### Situation projetée

## Détail implantation
